Intelligent Roof Bolting Drilling Operations

RAnderson, J.H. Fletcher & Company, with co-author L. Prosser, NIOSH-PRE gave a presentation to the Ground Control Conference **Improving the Capability for Real Time Assessment of Roof Conditions Through Intelligent Roof Bolt Drilling Operations.**

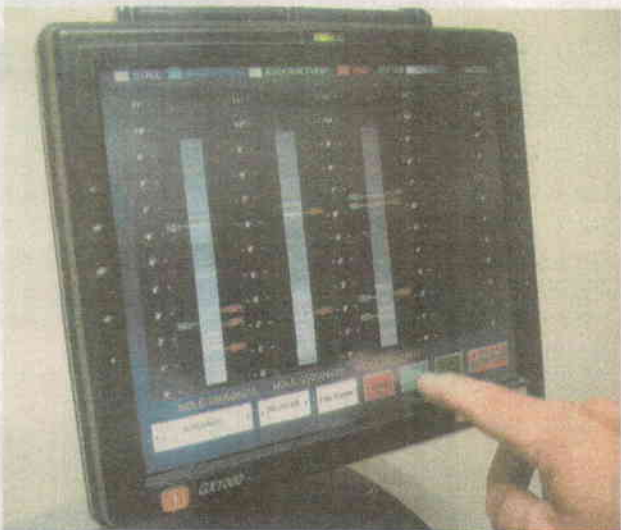
Fig 1 Fletcher Information Display

This all began in 1992 when a PLC was added to roof bolters. Drill control units were then added. In 1999 two foam voids were detected in concrete and the data was recorded and analyzed. Additional software was developed and recent improvements in analysis algorithms to detect anomalies in the roof structure as well as various display enhancements for real time

mapping and evaluation of roof structures have been incorporated into current Fletcher information display systems (see **Figure 1**).

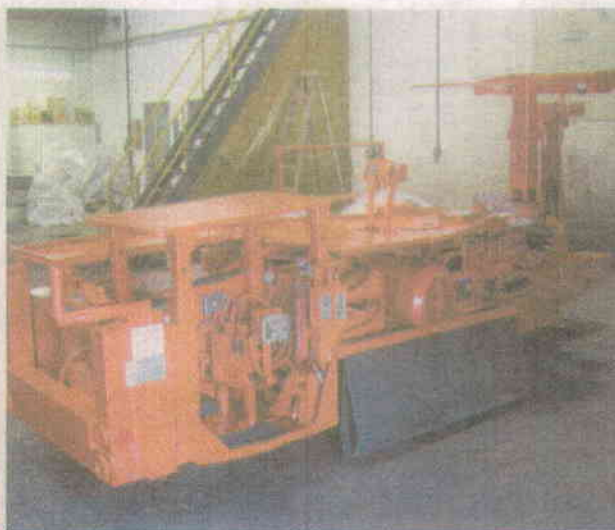
Fig 2 Rebuilt Roof Bolter

In another joint project with WVU, a test machine was built for use in an underground coal mine. An older single boom roof bolter was rebuilt with modern components, including the latest generation of drill head and drill control unit. The Fletcher information display was installed in an explosion-proof housing on the machine.

Figures 2 and 3 show the coal test machine and the information display.

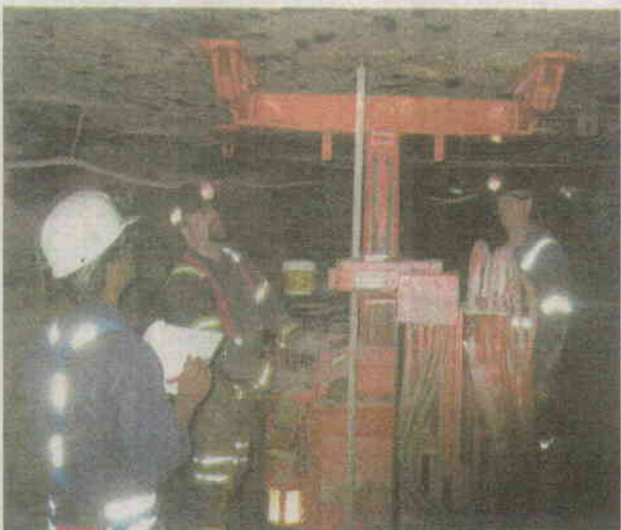
Fig 4 Testing in the Mine

The machine was first tested in the laboratory and then moved to a West Virginia coal mine. Testing in the mine is shown in **Figure 4**. The first location where the system was tested was close to the mine opening and showed very little change in the roof structure throughout the drilling depth. Approximately 60 holes were drilled at different feed pressure and RPM combinations. Two core drill samples were taken from this area for analysis at WVU. The drill data files on core drill samples were unremarkable showing a continuous homogenous material in the mine roof.

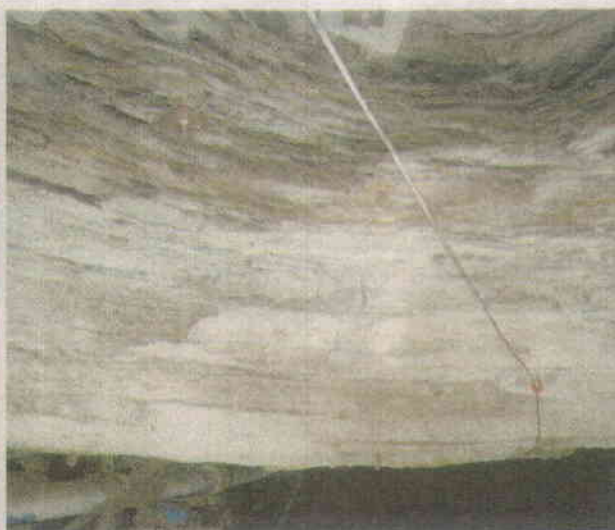
Fig 5 Roof Fall Area

The test machine was moved to another section of the mine where there had previously been roof problems including a large roof fall. **Figure 5** shows this area and gives a cross-section of the roof strata. In this area 30 boreholes were drilled and two more core samples were taken. The core samples had several discontinuities and the drill data files showed events as well. When viewing the whole graph side by side, it was

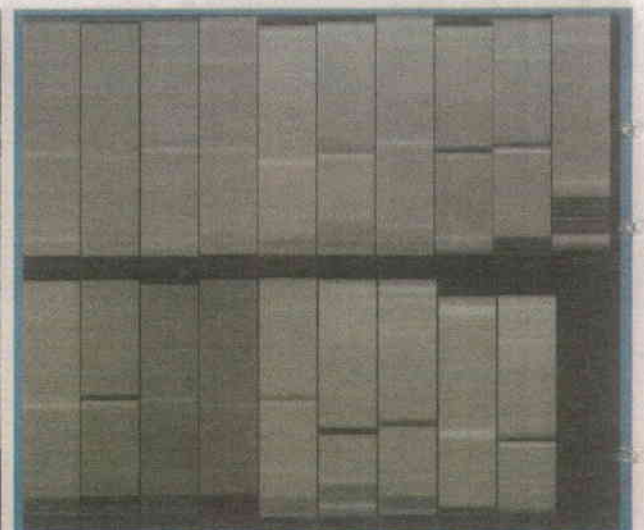
Fig 6 Discontinuity Trends

obvious that there was some change in roof strata at a depth of about 15" (see **Figure 6**).

Scoping holes were also analyzed using a small borehole scope less than 1" diameter. Video files were recorded for each hole. Discontinuities were found in almost every case at or near the location indicated by the drill data files. Fifteen more holes were drilled in this area with similar results. Even when no open voids were detected, the whole graph showed trends such as the locations of soft bands relative to the bolting horizon. The system was also tested underground in limestone mines with NIOSH accompanying J.H. Fletcher in observing these tests and reviewing these encouraging results.
